TECHNIQUES FOR OVERLAYING DETERIORATED
LANDING MAT. BARE BASE SUPPORT

MISCELLANEOUS PAPER S-70-23

Project 3782-63

C. D. Burns, W. N. Brabston

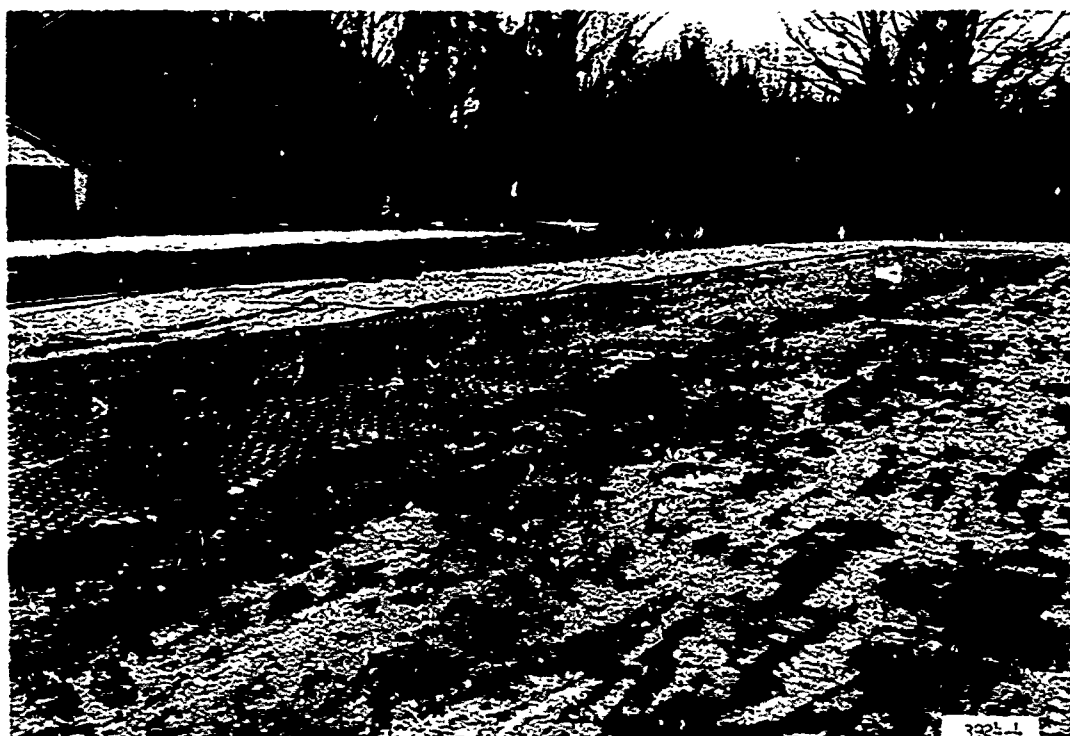
eight coverages of a 50,000-lb, pneumatic-tired self-propelled roller having seven tires, each inflated to 55 psi. After the final lift had been placed and compacted, the surface of the subgrade was fine-bladed with a road grader to a 2-1/2 percent crown and smoothed with a 10-ton steel-wheel roller. The average strength of the subgrade after construction was approximately 2.6 CBR. The entire subgrade was surfaced with M6 landing mat (see photograph 1). In order to produce a typical deteriorated landing mat surface, the M6 was trafficked until failure. Failure of the M6 mat was obtained with 18 coverages of a 25,000-lb SWL on a 20-20/22-ply rating (PR) tire inflated to 90 psi, followed by eight coverages of the same wheel and tire having a 30,000-lb SWL and 125-psi tire inflation pressure. A view of the M6 mat after failure is shown in photograph 2.

Photograph 2. Deteriorated M6 landing mat surface

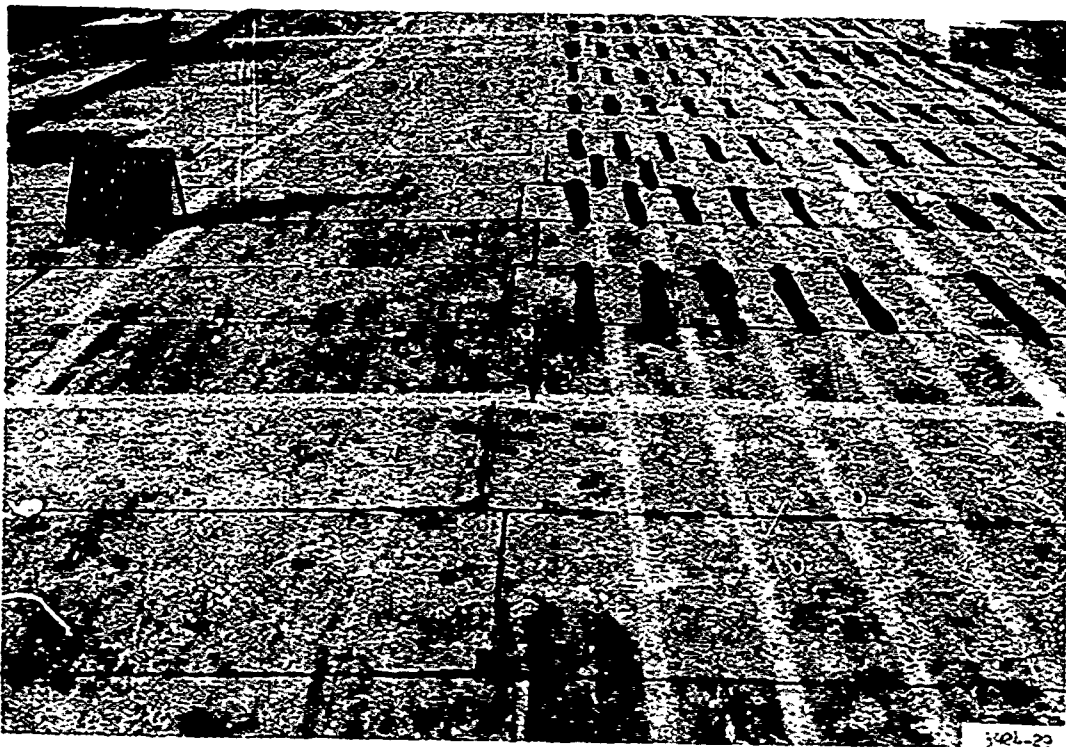
24. Item 1. A general view of item 1 after rearrangement of the mat at 26 coverages is shown in photograph 10. The first mat damage in item 1 appeared at 116 coverages when a small crack developed in an end-connector weld in panel 23. At 160 coverages, an additional three end-connector welds were cracked, but the item was still in serviceable condition. The first panel failure occurred at 210 coverages when the end connector of panel 23 sheared completely from the extruded part of the panel (see photograph 11). At 300 coverages, panel 17, which was two-piece AM2, failed due to severe cracks in both the end-connector weld and the center-line weld (see photograph 12). In addition to the two failed panels, there were eight panels with end-connector weld cracks. After 400 coverages of traffic, a total of 14 end-connector weld cracks had occurred. These cracks averaged about 2.5 in. in length and occurred mostly on the overlapping end connectors. The most severe cracks were in panel 14, where the end-joint weld was cracked almost entirely across the panel, and in panels 23A* and 19, both of which had large cracks on both ends of the end-connector welds. Panel 14 also had a severe crack in the center-line weld. At 457 coverages, panels 19 and 23A failed when the end connectors sheared off. At 500 coverages, panel 6 failed due to end-connector shear, and panel 14 failed due to longitudinal weld breaks. At this time, item 1 was considered failed, having six failed panels and 14 additional areas of panel breakage. A view of item 1 at failure is shown in photograph 13. During application of traffic, approximately 6.92 in. of rainfall was recorded in the test area. After periods of especially heavy rainfall, it was observed that a small amount of the sand in the leveling course had been washed from under the mat and deposited alongside the test section.

Photograph 10. Item 1 after rearrangement of mat at 26 coverages

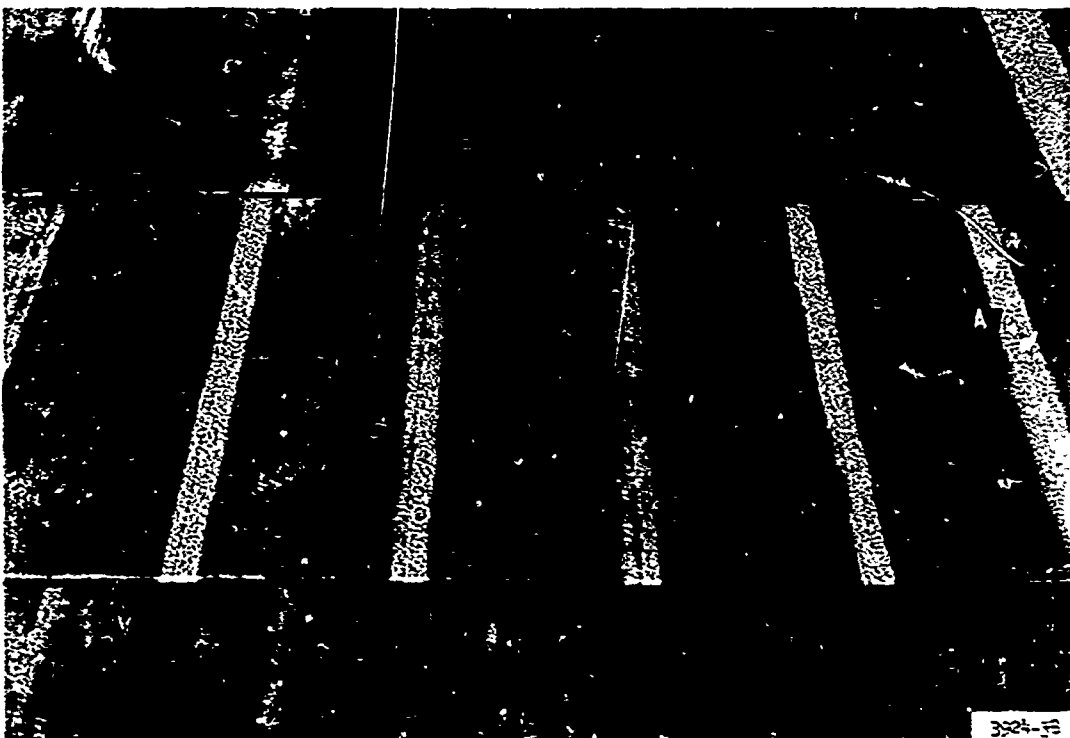
Photograph 12. Close-up of center-line weld failure on two-piece AM2

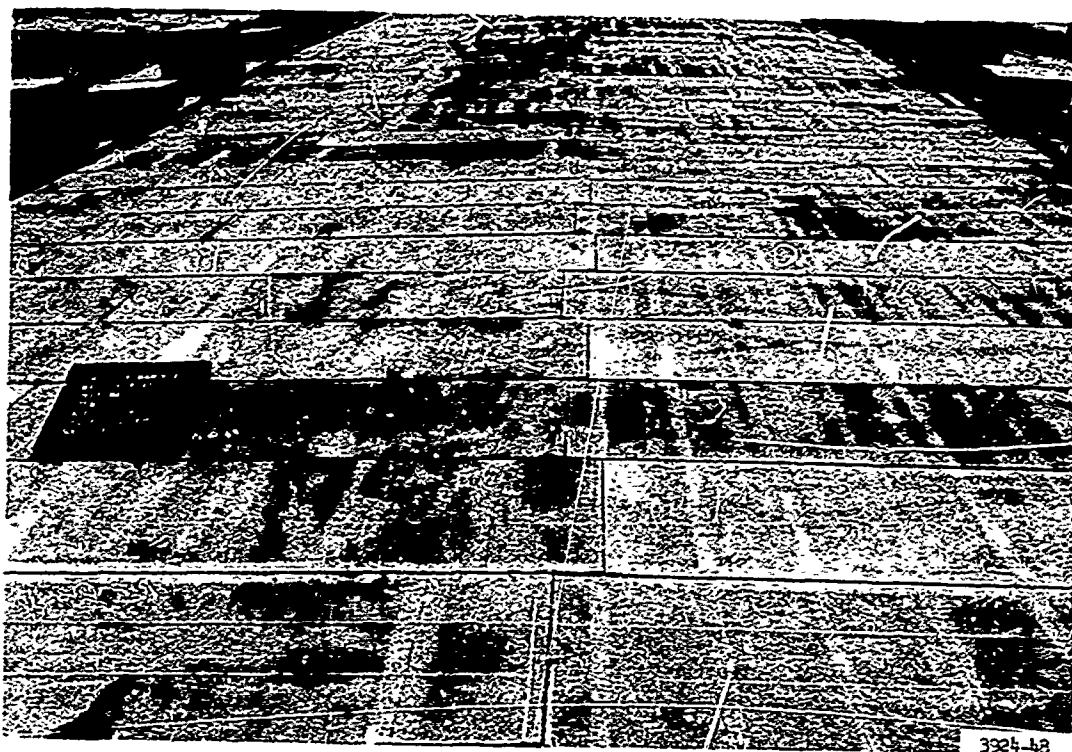
Photograph 13. Item 1 after failure at 500 coverages

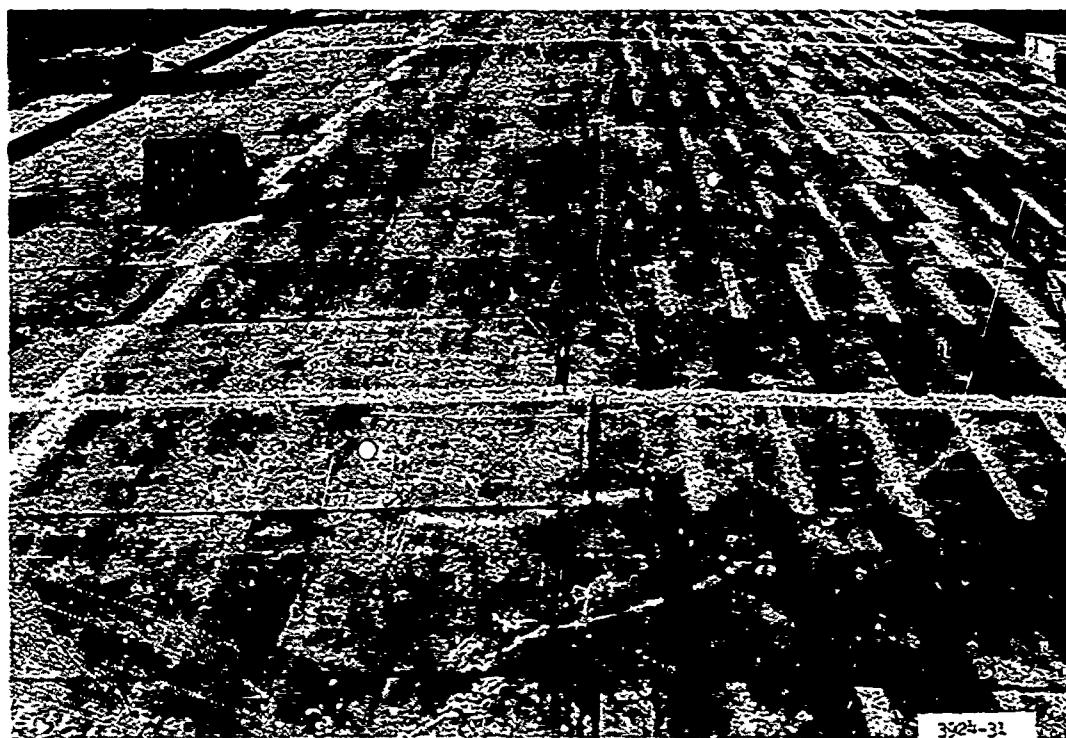
26. Item 3. A general view of item 3 after rearrangement of the panels at 26 coverages is shown in photograph 16. After 96 coverages, panel 16, which was two-piece AM2, developed cracks in the longitudinal weld and after 160 coverages, failed completely. At 160 coverages, there were also four panels with end-connector weld cracks. Traffic was continued to 500 coverages, at which time panel 58 failed due to end-connector shear. At this time, in addition to panel 58, there were 10 panels with end-connector weld breaks, which averaged about 1.7 in. in length. Overall, the item was in fair condition. Traffic was continued, and at 660 coverages, panel 66 failed due to end-connector shear. At 760 coverages, panel 58A failed from end-connector weld failure and item 3 was considered failed. A view of item 3 at failure is shown in photograph 17. At 760 coverages, in addition to the failed panels, there were 18 end-joint weld cracks in various panels in the item. The average length of the weld cracks was approximately 4.2 in. Also, there was one panel with a longitudinal weld crack about 18 in. long. During the application of the 760 coverages of traffic on item 3, approximately 8.12 in. of rainfall was recorded in the test area. It was observed that a small amount of the fines in the clay gravel was washed from under the mat, and there was some densification of the soil.

Photograph 16. Item 3 after joints were staggered at 26 coverages

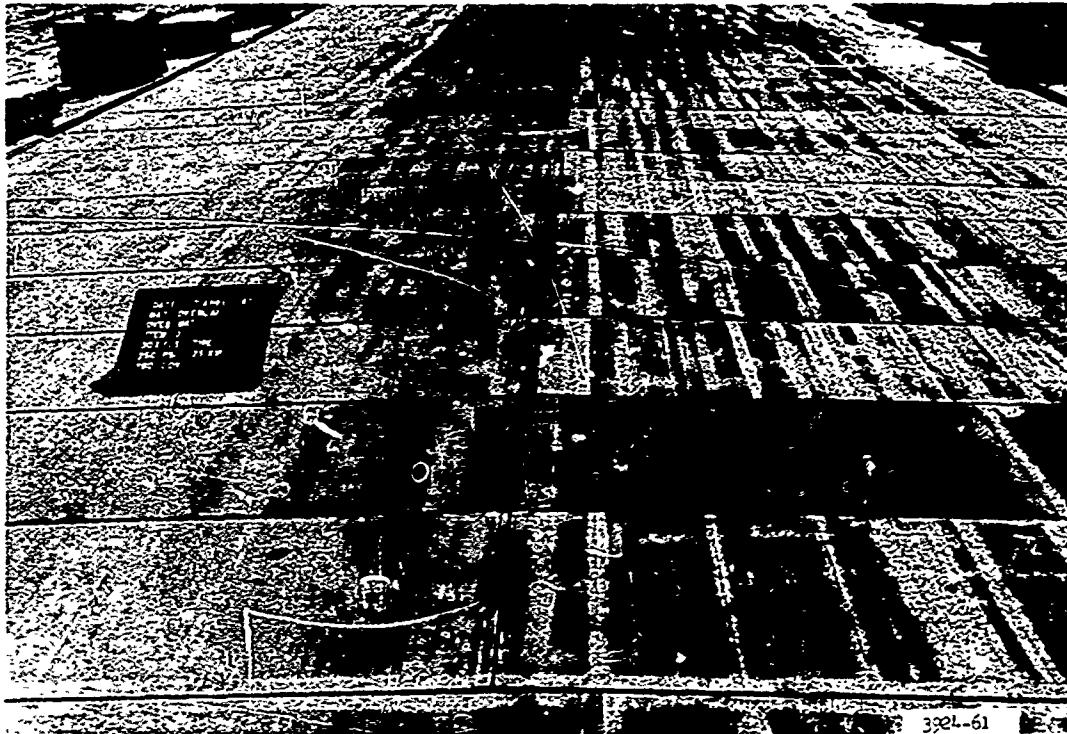
Photograph 17. Item 3 after failure at 760 coverages

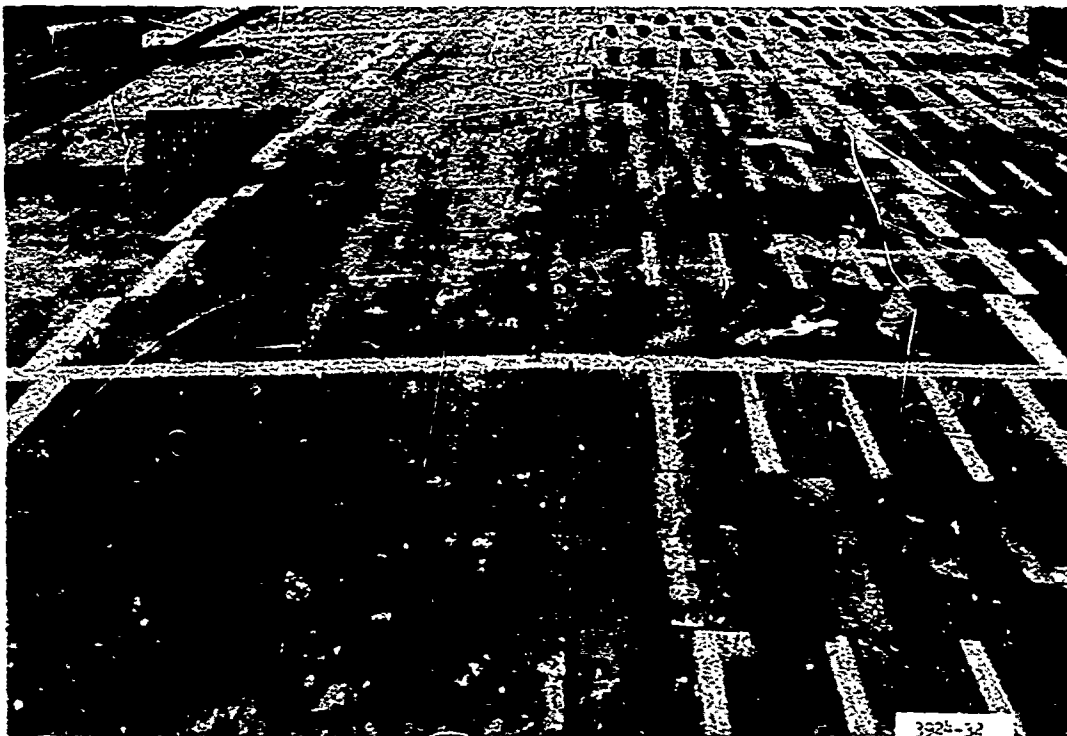
panels at 26 coverages is shown in photograph 18. The first mat damage was observed at 110 coverages when panels 92 and 94 developed cracks in the center-line welds. At 116 coverages, these cracks had progressed to about 20 in., and both panels had developed end-connector weld cracks. Generally, the item was in good condition. However, panels 92 and 94 began to deteriorate rapidly after 200 coverages, and panels 88 and 90 developed severe end-connector weld cracks. At 300 coverages, all four panels failed, and the entire item was considered failed. In addition to the failed panels, there were three panels in the item with end-connector weld cracks. A view of item 4 at failure is shown in photograph 19. As noted in paragraph 24, approximately 6.92 in. of rainfall was recorded in the test area during application of the initial 500 coverages of test traffic. Since the compacted lean clay soil in item 4 was protected with T16 membrane, the soil was not affected by the rainfall.

Photograph 18. Item 4 after joints were staggered at 26 coverages

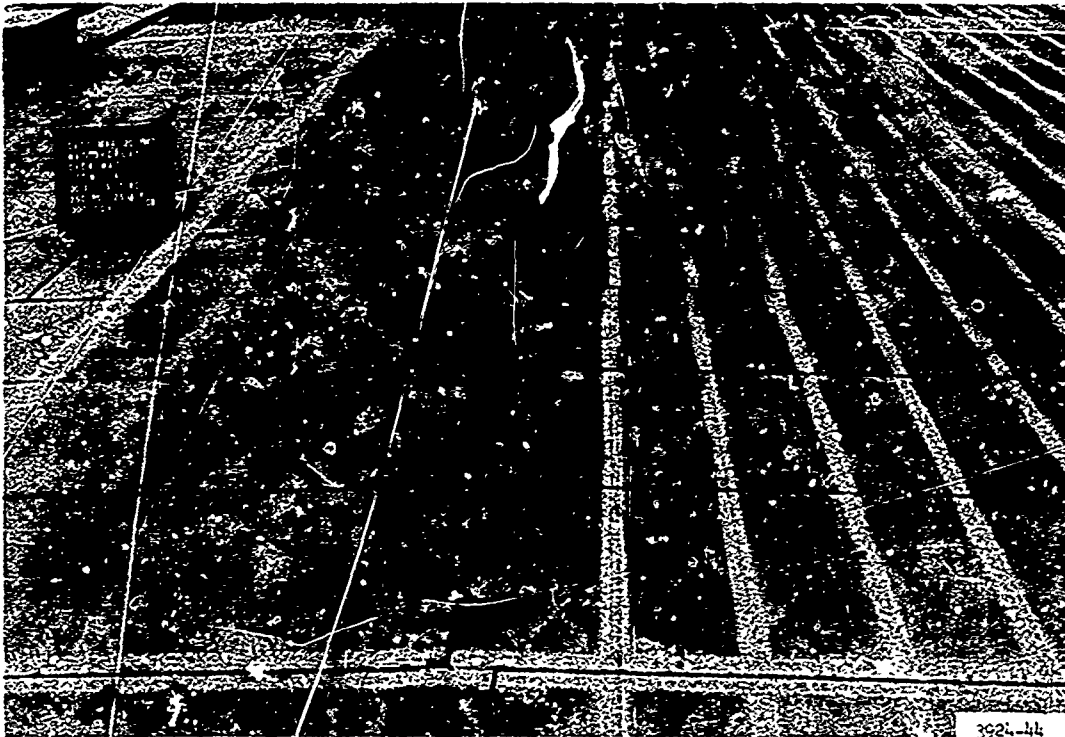
Photograph 19. Item 4 after failure at 300 coverages

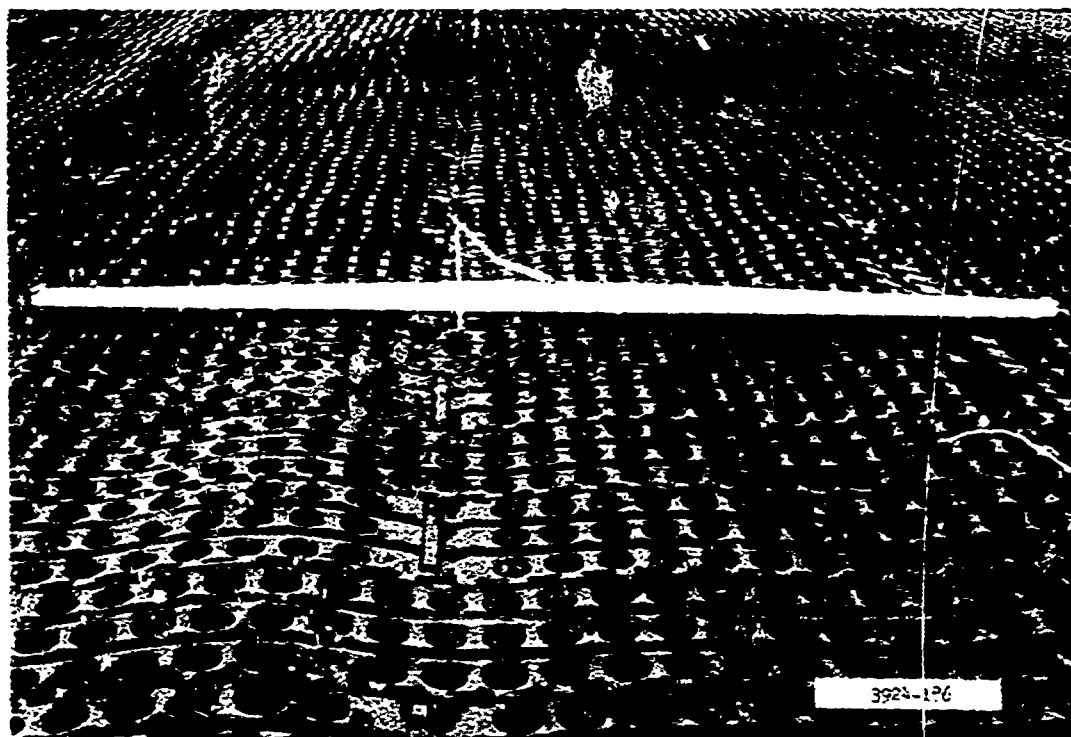
Photograph 24. Deformed M6 mat surface of test section 2 after traffic

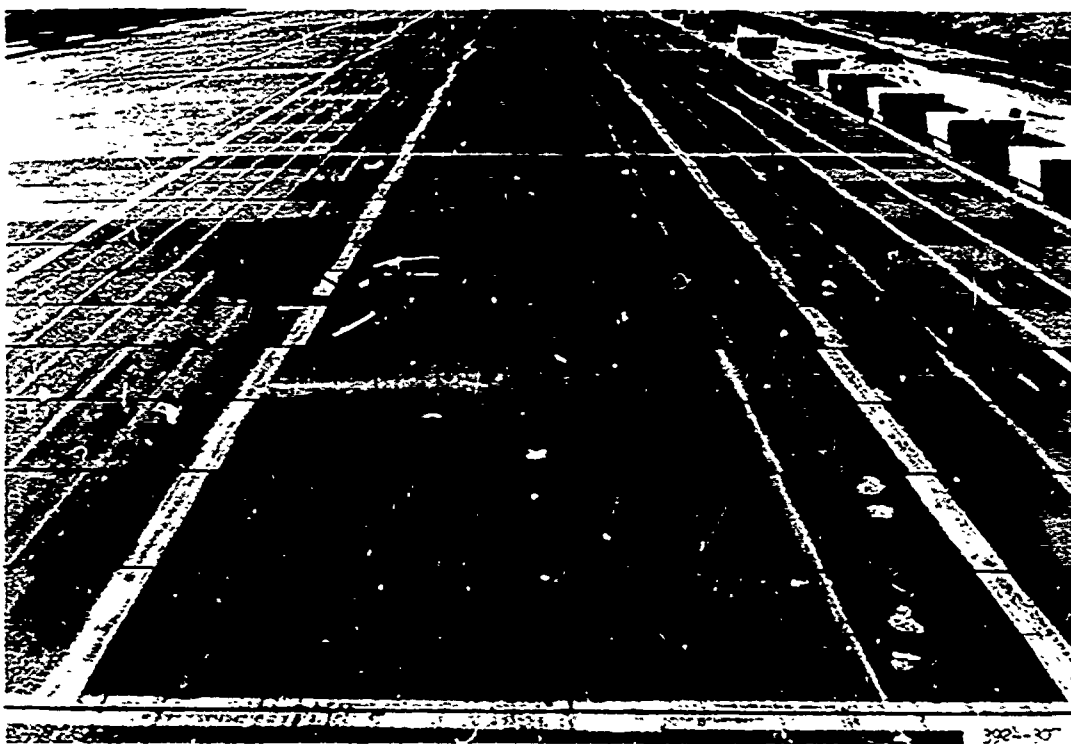
56. A total of 2000 coverages of test traffic was applied in lane 1; of these, 194 were applied during light to heavy rain showers. A total rainfall of approximately 2.71 in. was recorded in the test area during the wet-weather traffic periods. Mat breakage in lane 1 was negligible, and after traffic, the entire lane was in excellent condition. A view of lane 1 before and after traffic is shown in photographs 31 and 32, respectively.

Photograph 32. Lane 1, test section 2, after 2000 coverages of traffic

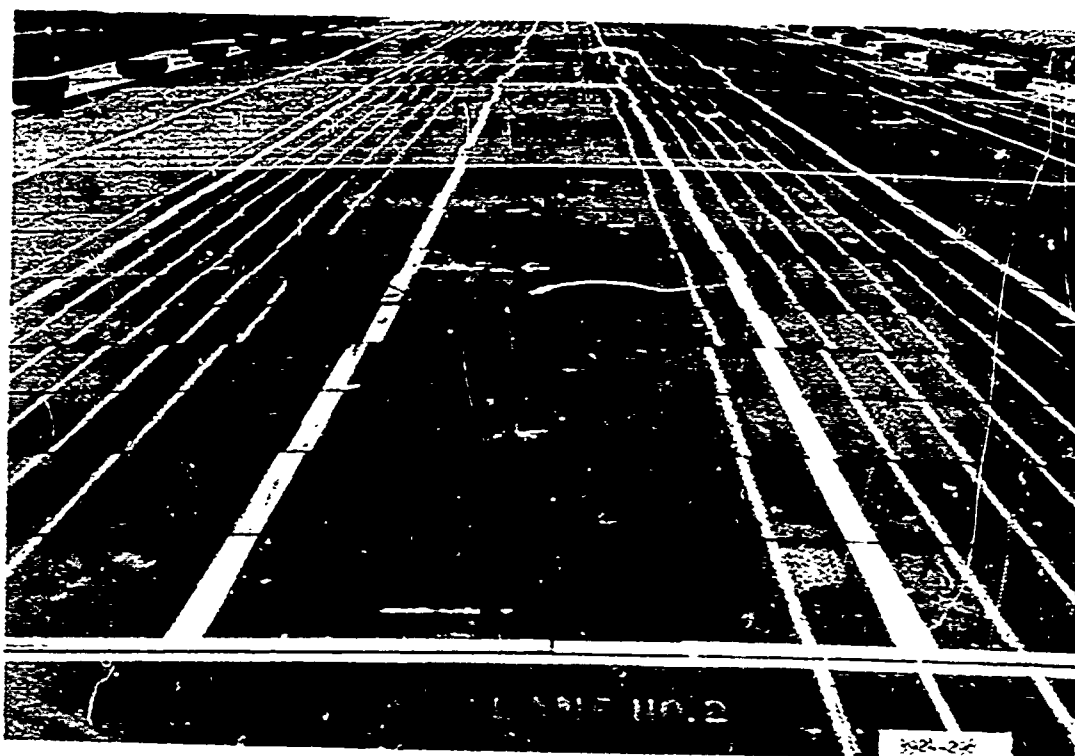
mat as a result of test traffic. Therefore, the test load was increased to 25,000 lb and traffic was continued. Approximately 298 coverages were applied during periods of light to heavy rainfall, and a total rainfall of 1.91 in. was recorded in the test area during the wet-weather traffic periods. As traffic was applied, small end-connector cracks developed in several panels in each item except items 3a and 3b; however, the mat breakage generally was minor and of little detriment to mat performance. During the application of traffic with the 25,000-lb SWL, it was observed that generally there was greater mat deflection in items 4a, 4b, 5a, and 5b (i.e., those items having the continuous longitudinal joint) than in the four other items. Traffic was continued until 1800 coverages had been applied with the 25,000-lb SWL, making a total of 2000 coverages of test traffic. Overall, the test lane was in excellent condition after traffic. A view of lane 2 at this time is shown in photograph 34.

Photograph 34. Lane 2, test section 2, after 2000 coverages of traffic

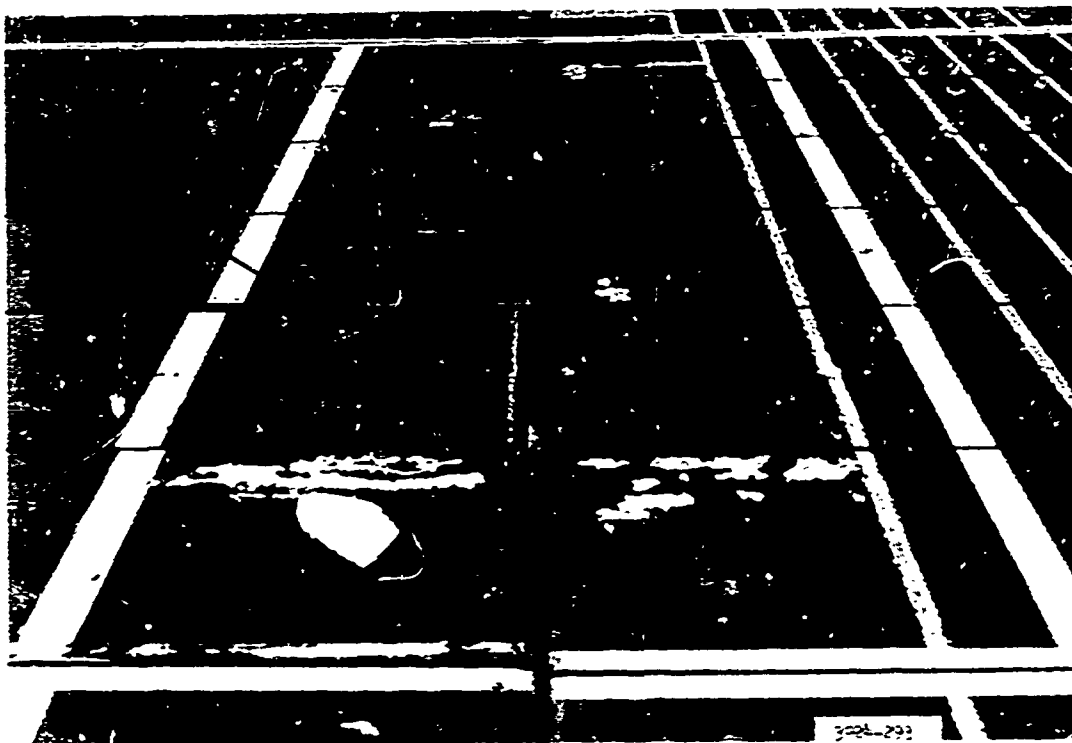
66. In lane 3, mat damage resulting from test traffic varied from none in item 2 to actual panel failures in items 4b, 5a, and 5b. Thus, it was again indicated that the performance of the items with the continuous longitudinal joint was not so good as that of the other items. Maximum mat deflections were somewhat higher in all items of lane 3 than in the respective items of lanes 1 and 2. Also, it is possible that some bridging of the mat occurred in lane 3.

Photograph 37. Item 5b, lane 3, after 2000 coverages of traffic

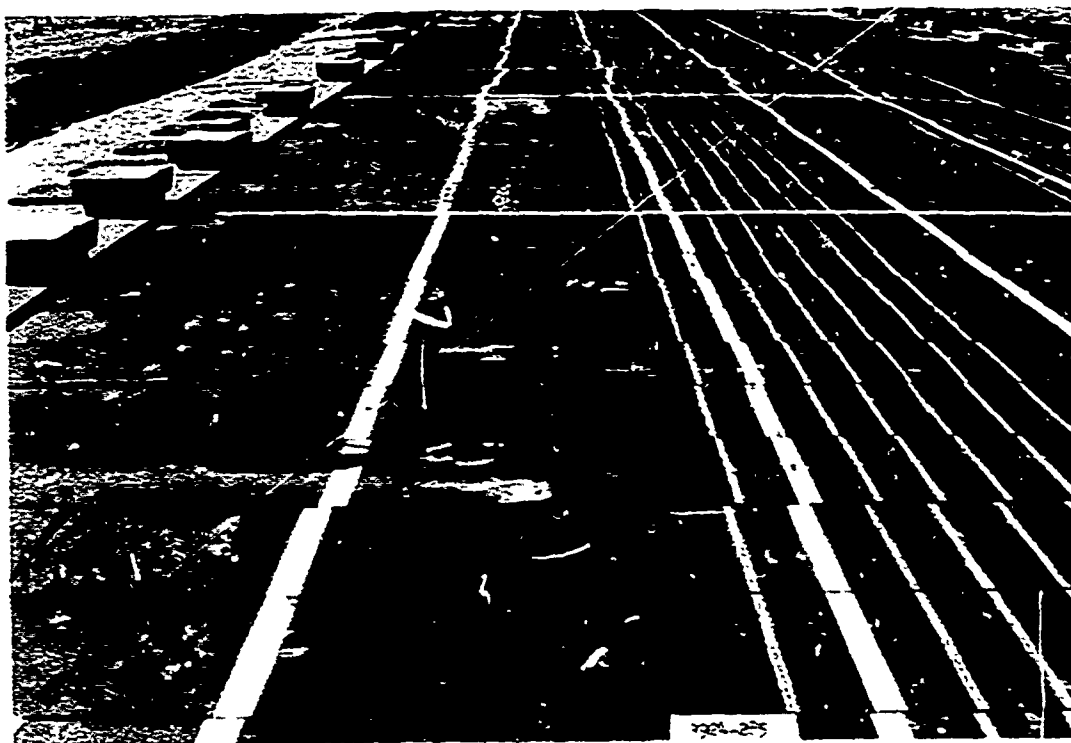
58. A view of lane 3 before traffic is shown in photograph 35. A total of 2000 coverages of test traffic was applied in lane 3 with the 25,000-lb SWL and 250-psi tire inflation pressure. Approximately 470 coverages were applied in periods of light to heavy rain showers, and a total of 2.86 in. of rainfall was recorded in the test area during wet-weather traffic periods. As traffic was applied, end-connector weld cracks developed in each item except item 2, and C-rail web cracks were found in one or two panels in items 1, 3b, 4a, and 5b. A total of 2000 coverages of traffic was applied in lane 3. Mat breakage after traffic consisted of minor weld cracks in items 1, 2, 3a, 3b, and 4a, and these items were in excellent condition. However, there were 1, 2, and 1 failed panels in items 4b, 5a, and 5b, respectively. Panel failure in each case was due to total failure of the end-connector weld and complete separation of the end connector from the main body of the panel. A view of items 3b and 5b after traffic is shown for comparison in photographs 36 and 37, respectively. A general view of lane 3 after traffic is shown in photograph 38.

Photograph 38. Lane 3, test section 2, after 2000 coverages of traffic
